# Manhole Inspection Summary

Manhole # S19Y\_\_024MH

Insp Date: **6/2/08 10:58 AM**

**Location** Address: **1901 griffis av**

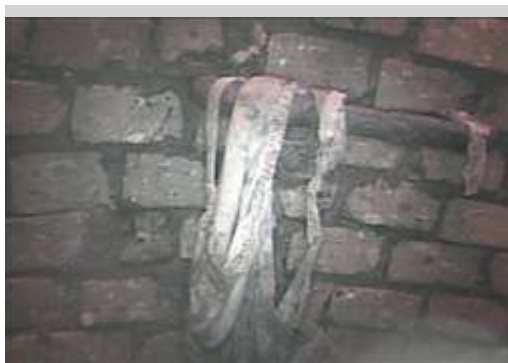
Defect 5

☒ **Evidence Of Surcharge** Depth: **7** (ft.) ☐ Active Surcharge Present

surcharge evidence

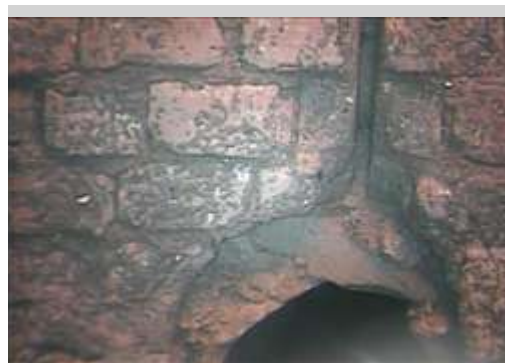
Defect 4

Condition: ☐ Sound ☐ Cracked ☐ Root Intrusion ☐ Loose Brick ☒ **Deteriorated**

deteriorated barrel bricks below vertical saw cut

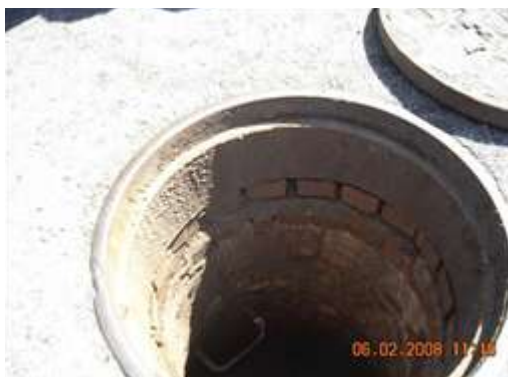
Defect 3

☒ **Leaks**

Condition: ☒ Sound ☐ Cracked ☐ Root Intrusion ☒ **Loose Brick** ☐ Deteriorated

frame leaks, chimney loose bricks

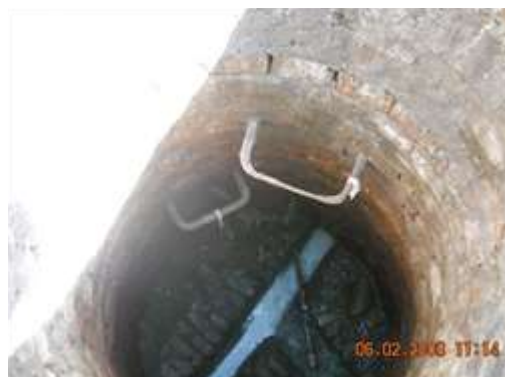
Defect 2

Count: **3** Missing: **0** ☒ **Corroded**

corroded steps

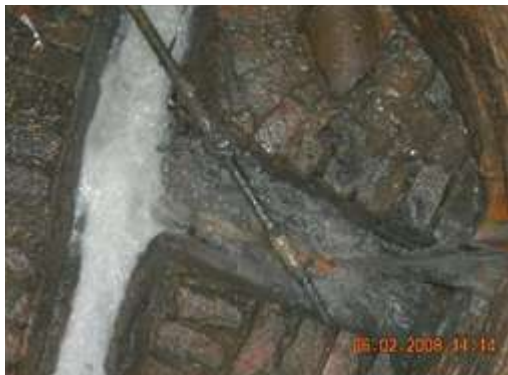
### Defect 1

Condition: ☐ Sound ☐ Cracked ☐ Root Intrusion ☐ Deteriorated ☐ Leaks ☒ **Debris**

debris in channel

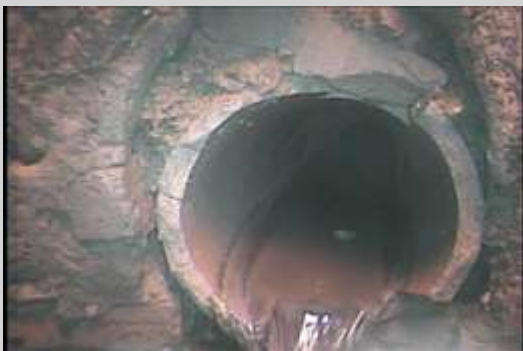
3 O'Clock Inflow

Pipe Height: **8.4** (in.) Rod and Bar (Angled)  
Pipe Material: **Clay** ☐ Pipe Lined  
Invert Depth: **7.45** (ft.) Flow Characteristics: **Fast**  
Deposits: ☒ None ☐ Mud ☐ Sludge ☐ Debris ☐ Grease  
Silt Depth: **0** (in.) Deposits Extent:  
Infiltration: **None** Pipe Seal Cond: **Broken**

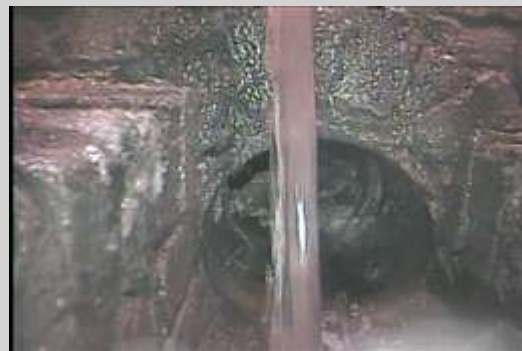
Drop In @ 3 O'Clock

Drop: **Outside** Rod and Bar  
Angled: **Yes** Reading: **8.09** (ft.)  
Inv Depth: **9.09** (ft.)  
Drop Condition: **Clogged**
